# The effects of plasma treatment on the microstructure of metals

Paul Craddock and Janet Lang

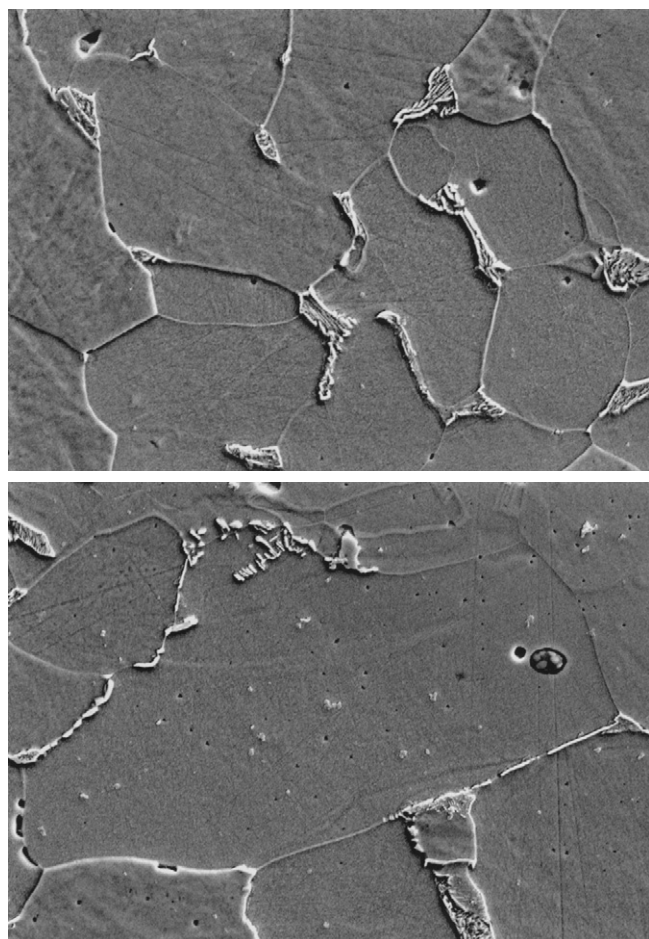
Figure 7: SEM micrographs of the structure of linch pin 945 (x350). Above: before treatment, below: after treatment. Note the grain size has increased, the pearlite has become much more distinct and the carbides have precipitated at the grain boundaries.

None of the artefacts selected had a martensitic structure; moreover, the carbon content of samples 935, 939 and 945 would have been too low for any martensite to have formed, no matter what heat treatments had been applied. Thus according to some of the claims made previously, plasma treatment should have caused no change to the structure. In fact the structure of all the iron artefacts was changed by the treatments as evidenced by both their appearance (Figs 7–8, Table 1) and the hardness of those tested (Table 2). On sample 935 evidence of surface working was preserved in the mineralised layers, but after treatment these layers had disappeared. On three of the artefacts (samples 938, 945 and 946) grain growth had taken place during the treatment, and

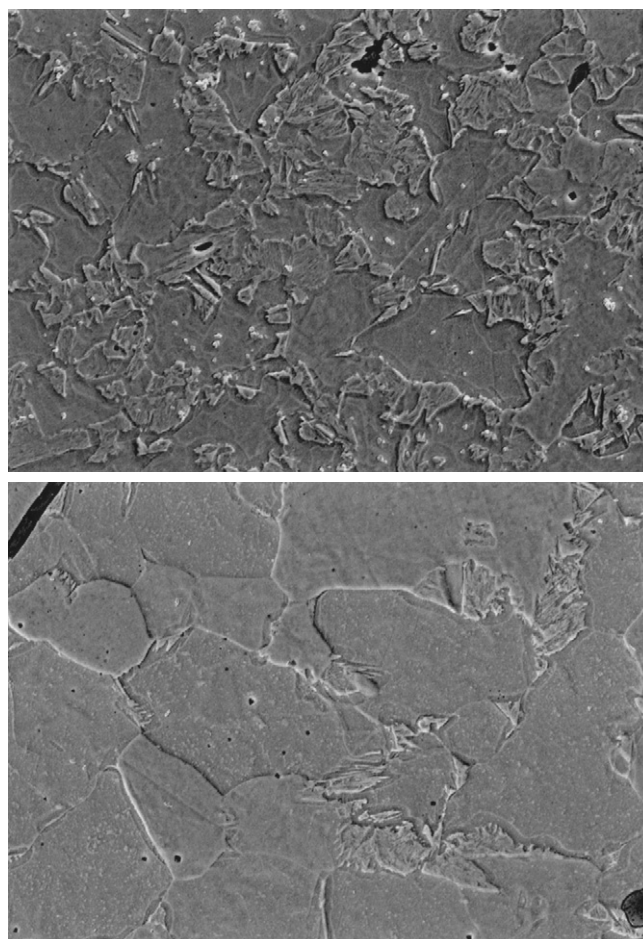
| Sample no (BM Acc no) | Inclusions | Etched structure | Changes after plasma |
|---|---|---|---|
| 938 Knife<br>(OA5691) | Few small elongated inclusions, mainly found parallel to the surface. | Banded structure of irresolvable pearlite and ferrite with some proeutectoid ferrite. | Pearlite now resolvable. Appearance of some disturbance in the grain boundaries. |

Figure 8: SEM micrographs of the structure of knife 938 (x350). Above: before treatment, below: after treatment. Note the grain size has enlarged, there is some precipitation within the grains and some of the pearlite has become more resolvable.

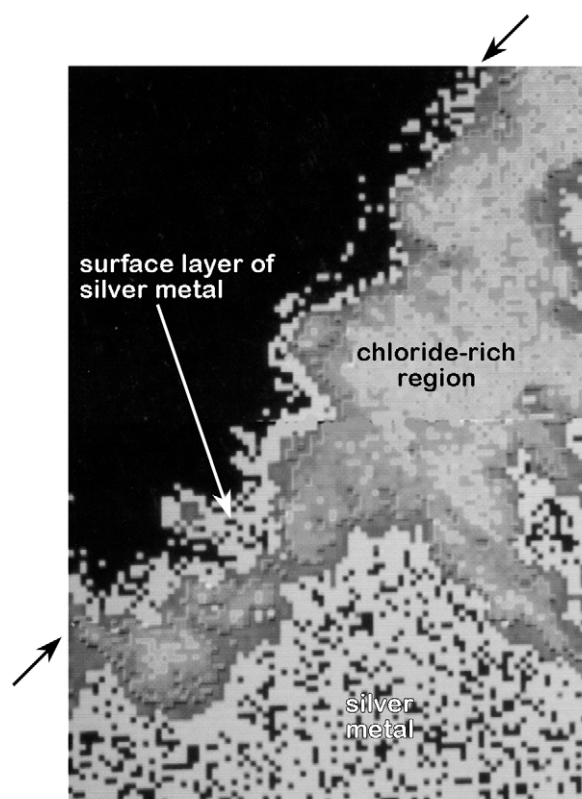
Figure 9: Distribution of chlorine in the corrosion of the silver bowl (1939, 10-10,8) after treatment. The chloride-rich regions are unchanged corrosion overlain with a thin layer of metallic silver from the reduction of the surface corrosion. The arrows show the approximate line of the original surface. Image height 900µm.
