# English steelmaking in the seventeenth century: the excavation of two cementation furnaces at Coalbrookdale

*ABSTRACT: This paper describes the excavation of the first cementation steel furnaces in England, built by Sir Basil Brooke at Coalbrookdale early in the 17th century. The coal-fired furnaces were in operation from c1619 to the end of the 17th century, and formed part of a much larger ironworking complex. Excavation revealed the remains of two furnaces and associated buildings, constructed in at least two phases. This paper also includes the metallurgical analysis of refractory materials, as well as discussion about the rôle of the furnaces in the broader context of English steelmaking of the period.*

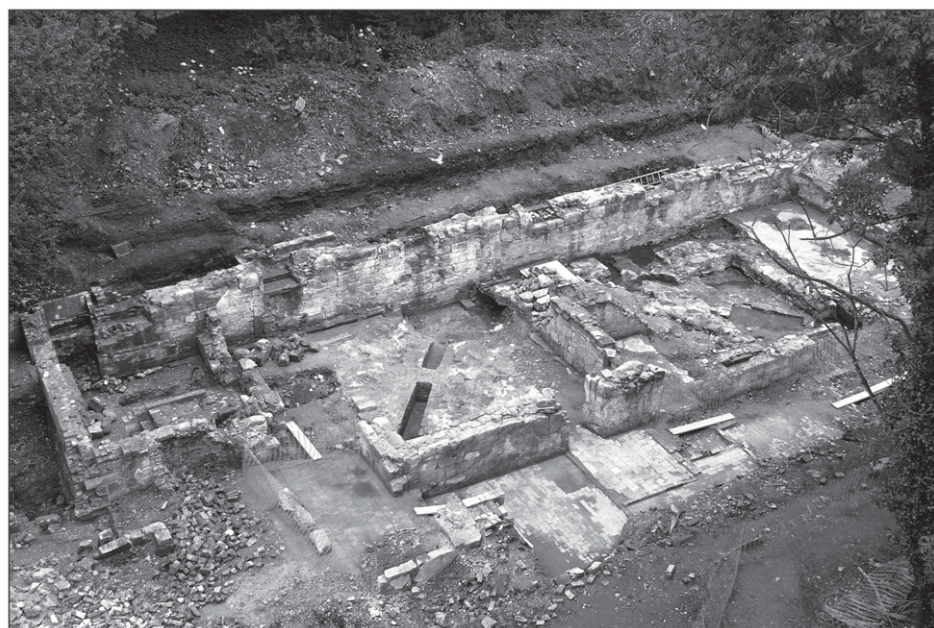
- Steel furnaces
- Other elements of the steelhouse phase (17th century)
- Malthouse structures (18th century), later converted to tenements (19th century)
- Tenement structures (19th century)

*Figure 5: Oblique overhead view of the site after excavation in 2005, showing the furnace bases, ancillary structures and other features. Photograph courtesy of Telford and Wrekin Council; key drawing by Paul Belford and Sophie Watson.*

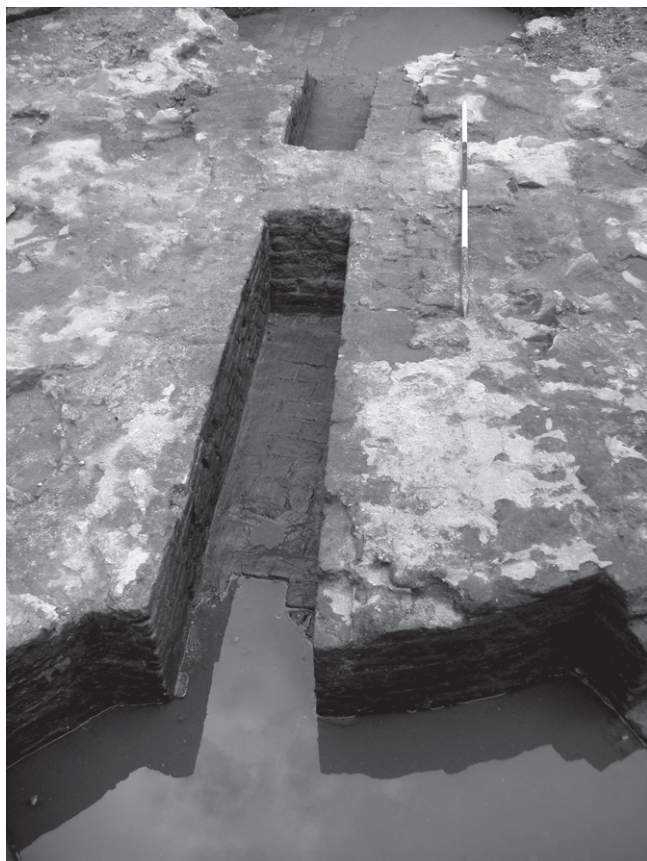
Figure 6: The northern ash pit of the northern furnace after excavation. Scale 2 metres. Photograph by Paul Belford.

extension was clearly evident in the ash pit (see Fig 6 above). The bricks used for the expansion were very similar to the original, but were not properly keyed in to the previous build. In addition, the south side of the north-western pit entrance steps out to 610mm (24in). There was no clear indication of two builds in the foundation mortar impressions. This may be simply because of the irregular nature of the construction, or it may reflect the extent of rebuilding. On the north-east side there are impressions of more regular blocks, up to 600mm (2ft) long, suggesting the presence of a stone facing-course. Three buttresses were identified, in various states of preservation. A fourth probably existed on the south side.

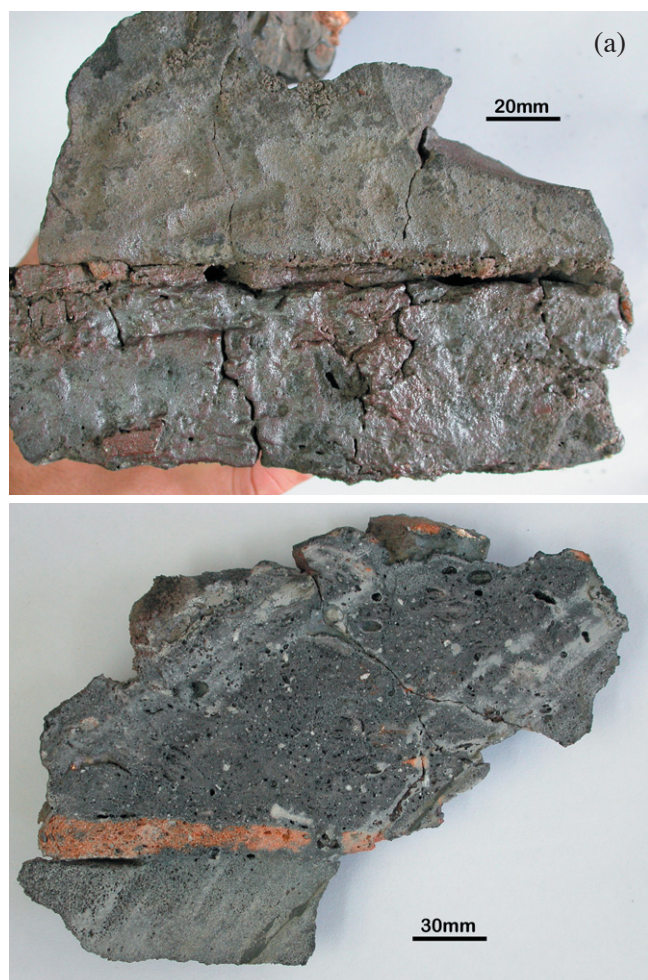
Figure 10: Sample 2, (a) refractory stone and brick and (b) after sectioning.

Sample 2 comprises a piece of sandstone adhering to a brick (Fig 10). The junction between these two components was clearly deliberate, as there is a line of clay mortar between the two.
